PRODEMAND

YMMS: 2008 Chrysler Aspen Limited

Engine: 5.7L Eng

MODULE-POWER-BLOWER MOTOR

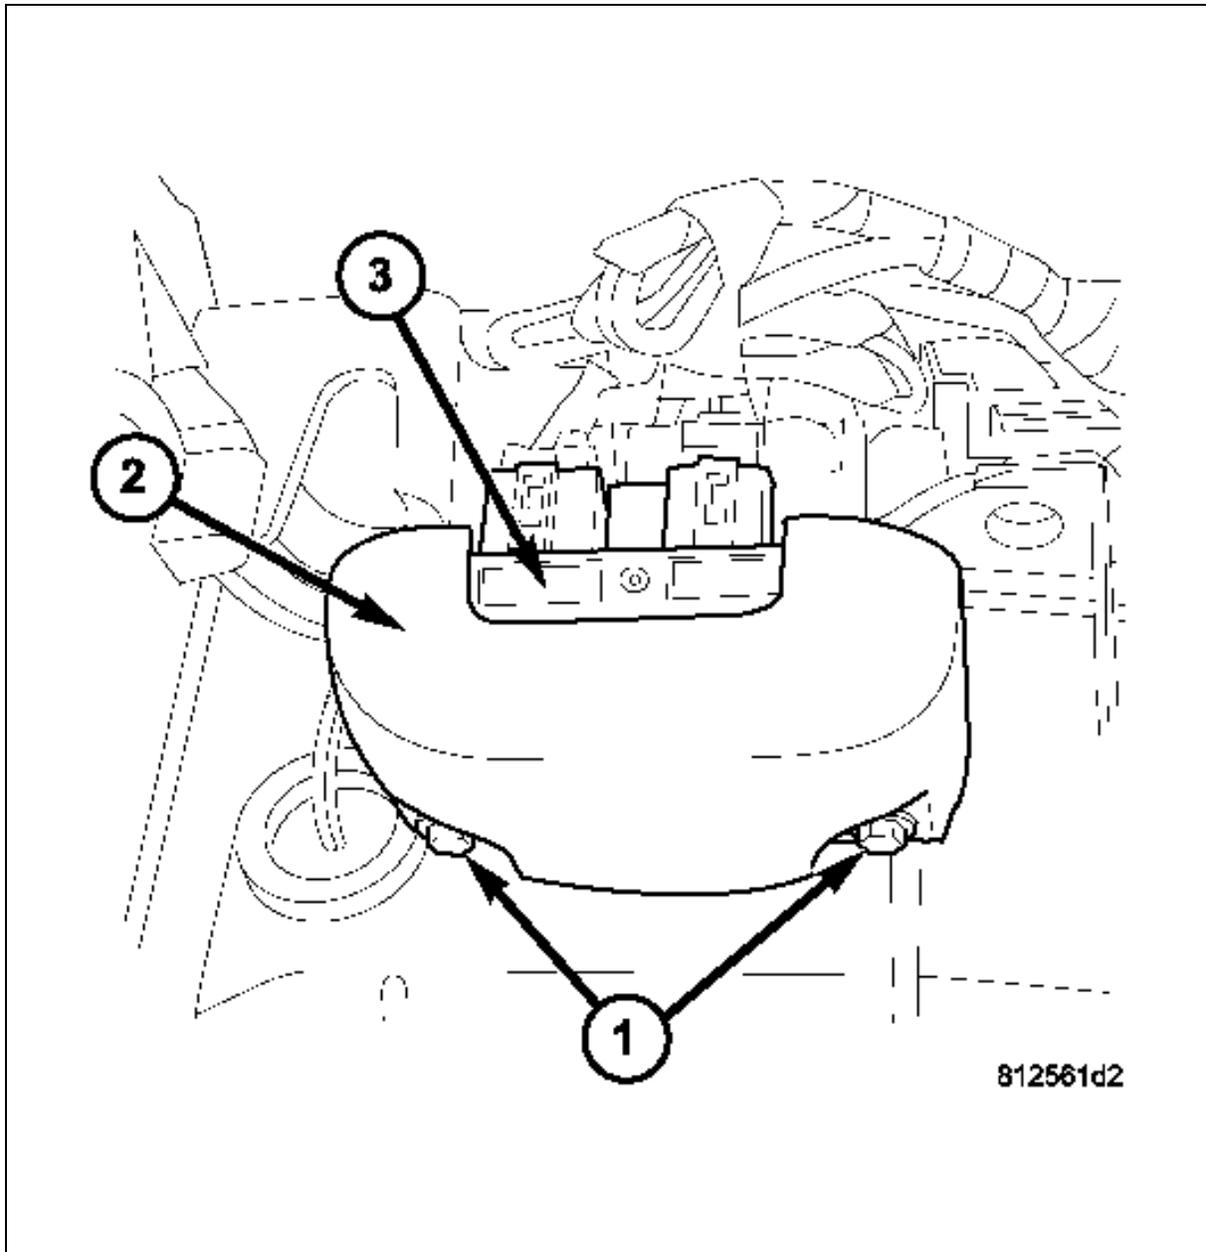
Fig 2: Locating Screws Securing Trim Cover

1. Disconnect and isolate the negative battery cable.
2. If equipped with a trim cover (2), remove the two screws (1) that secure the trim cover over the blower motor power module (3) located below the right side of the instrument panel and remove the cover.

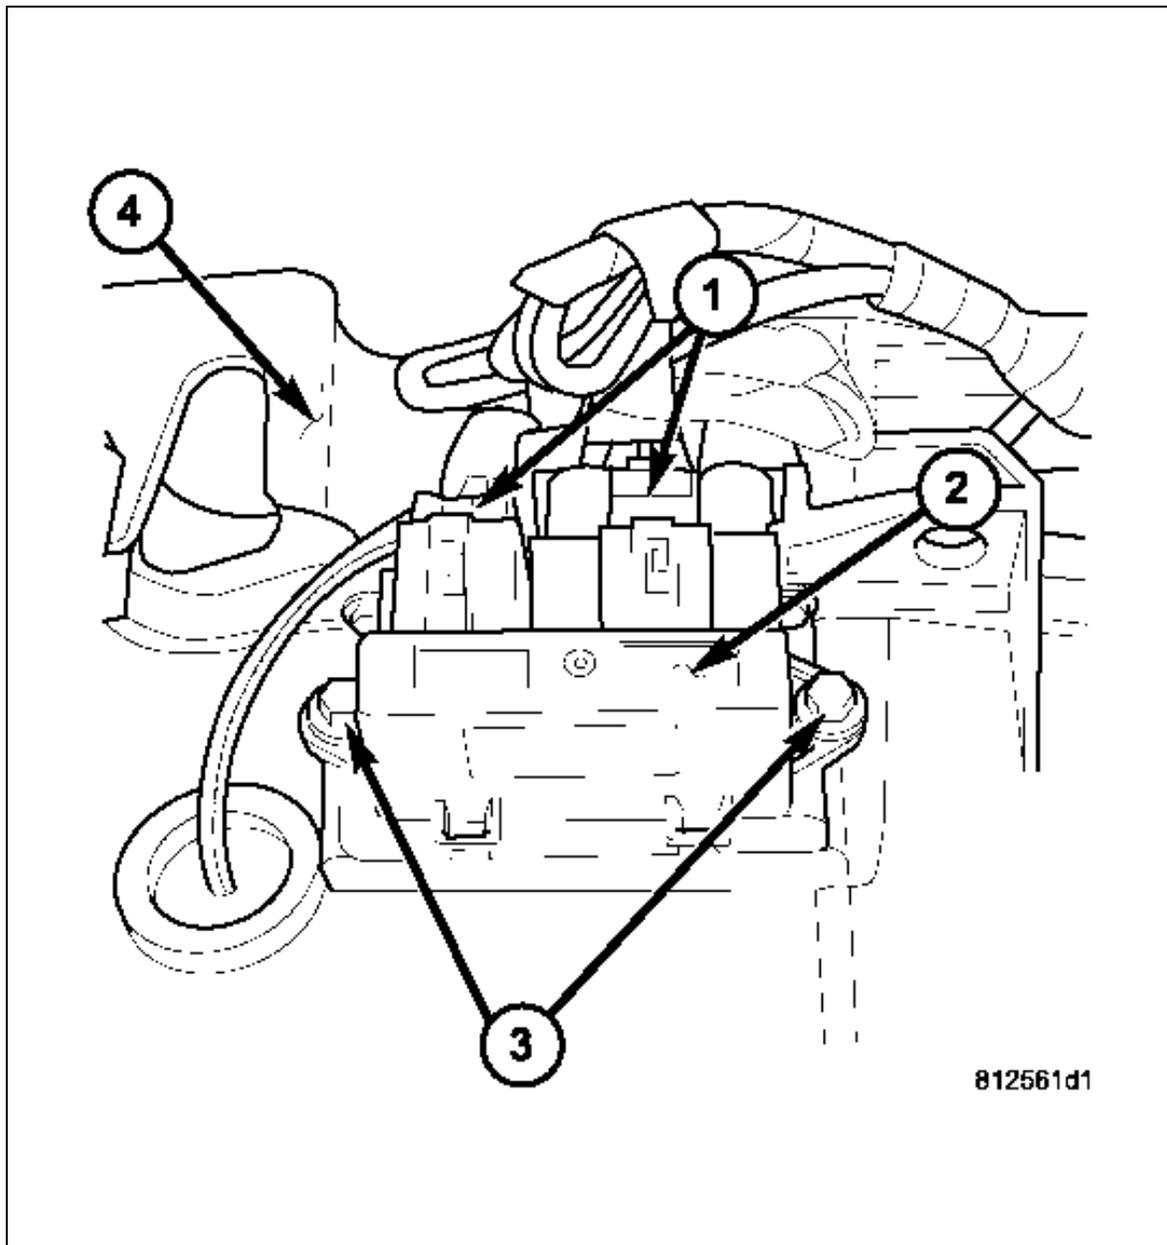
Fig 3: Identifying Wire Harness Connectors, Blower Motor Power Module, Screws, And HVAC Housing

3. Disconnect the two wire harness connectors (1) from the blower motor power module (2).
4. Remove the two screws (3) that secure the blower motor power module to the front HVAC housing (4).
5. Remove the blower motor power module from the front HVAC housing.
